Test Report
Order no. 2624249

Order: Determination of performance characteristics for load-bearing panels for use as floor-decking on beams acc. to EN 12871:2013

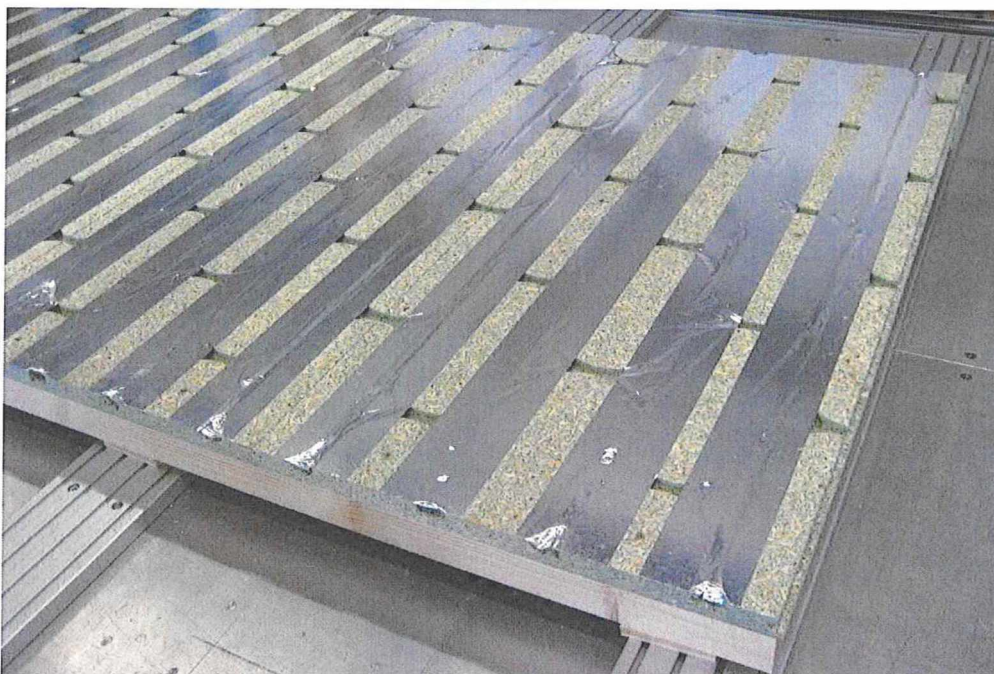
Fig. 2:
Top view on the JSD
particleboard

Installation: on the support beams (long side of the boards perpendicular to the axis of the beams, fixation with self-drilling screws at a size of 5x60 mm (Domax, DoP-310506-2019), without pre-drilling, for distance between the screws and edge distance see Annex, see Fig. 1 and 2

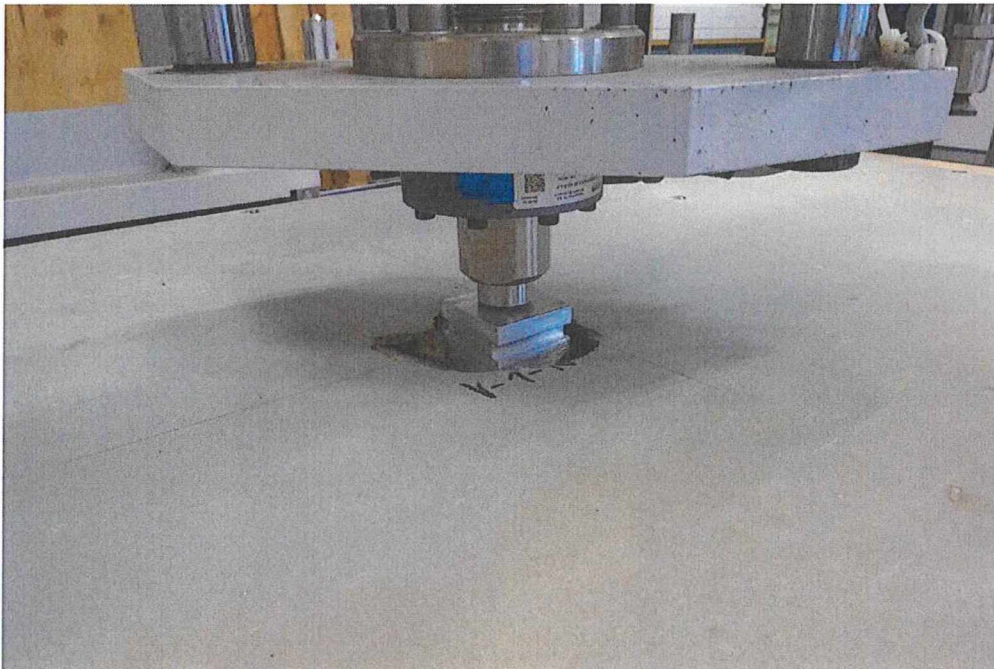
Fig. 5:
Local punching failure (top view).

The failure occurred by local punching failure, see Fig. 5 and Fig. 6.

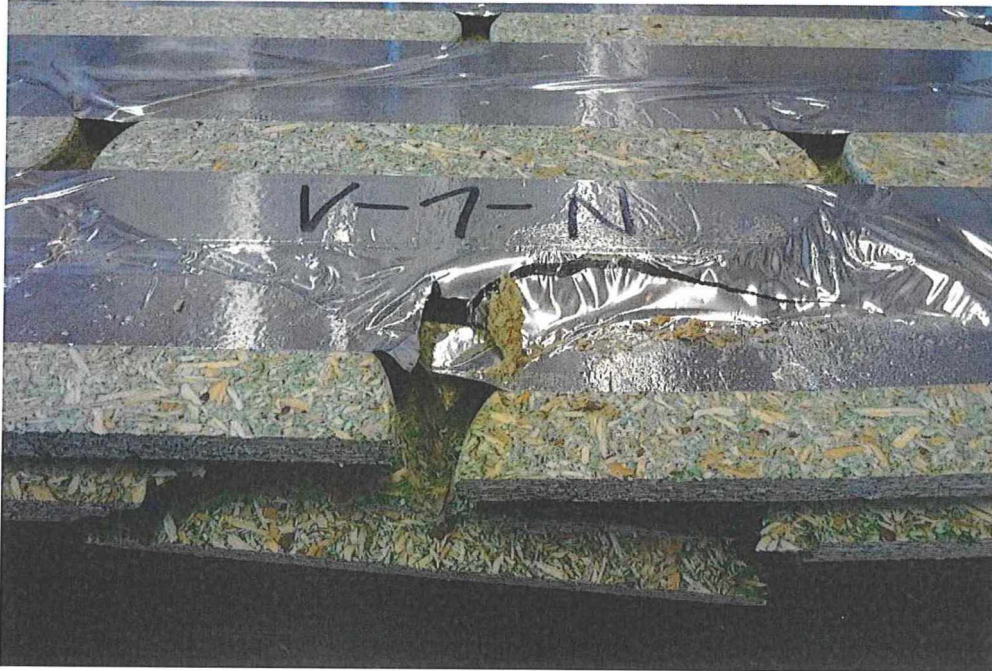
Fig. 6:
Local punching failure (view after removing of cement-bonded board).
